Manhole Inspection Summary

Manhole # S47E2_015MH

Location Address: **4101 Curtis Ave.** Cross Street: **Plum-Olmstead**

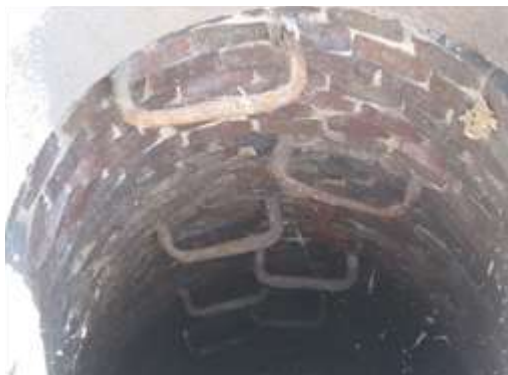
Steps Count: **8** Missing: **0** ☒ **Corroded**

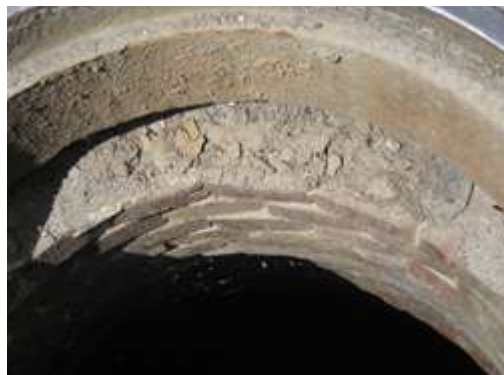
Defect 1

Frame Offset: **2.5** (in.) Condition: ☒ Sound ☐ Cracked ☐ Leaks

Frame offset

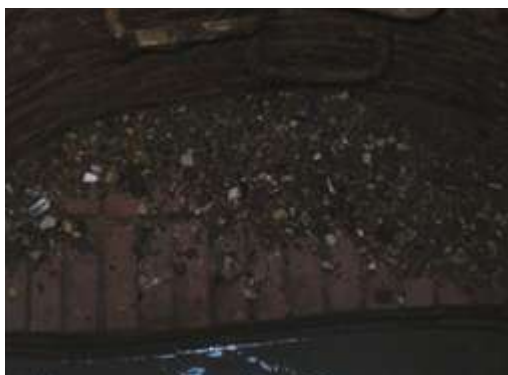
Defect 2

Debris on bench

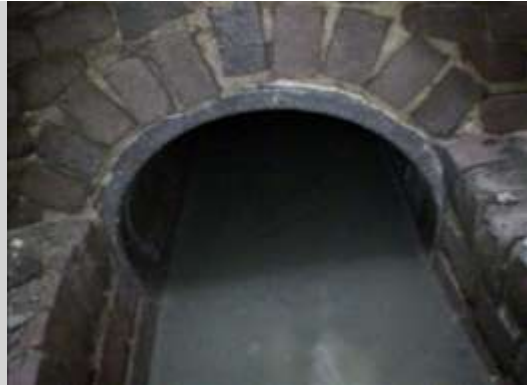
12 O'Clock Outflow

18 in. Circular Gravity Sewer
Pipe Out @ 12 O'Clock

Pipe Height: **18** (in.) Rod and Bar (Angled)
Pipe Material: **Clay** ☐ Pipe Lined
Invert Depth: **13.46** (ft.) Flow Characteristics: **Fast**
Deposits: ☒ None ☐ Mud ☐ Sludge ☐ Debris ☐ Grease
Silt Depth: (in.) Deposits Extent:
Infiltration: **None** Pipe Seal Cond: **Sound**

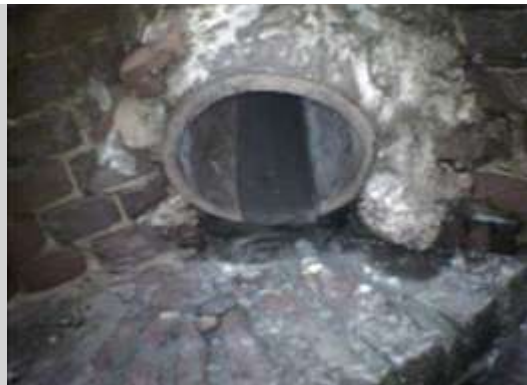
2 O'Clock Inflow

8 in. Circular Gravity Sewer
Pipe In @ 2 O'Clock

Pipe Height: **8.4** (in.) Rod and Bar (Angled)
Pipe Material: **Clay** ☐ Pipe Lined
Invert Depth: **12.05** (ft.) Flow Characteristics: **Fast**
Deposits: ☒ None ☐ Mud ☐ Sludge ☐ Debris ☐ Grease
Silt Depth: (in.) Deposits Extent:
Infiltration: **None** Pipe Seal Cond: **Sound**

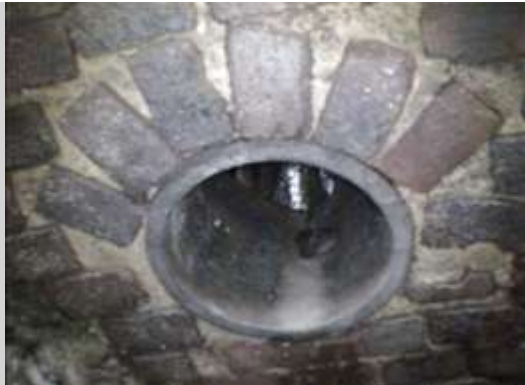
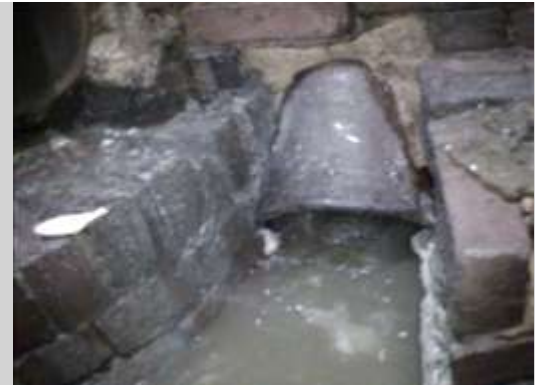
3 O'Clock Inflow

8 in. Circular Gravity Sewer

Pipe In @ 3 O'Clock

Drop In @ 3 O'Clock

Drop: **Outside** Rod and Bar
Angled: **Yes** Reading: **12.18** (ft.)
Inv Depth: **13.18** (ft.)
Drop Condition: **Open**

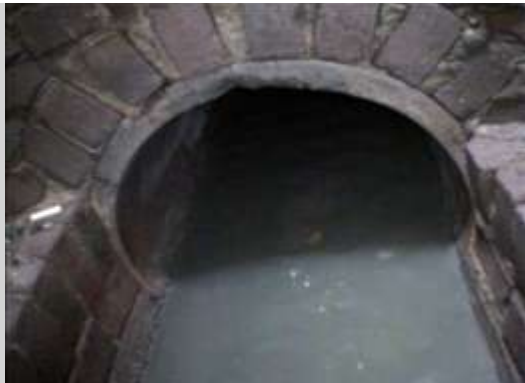
6 O'Clock Inflow

18 in. Circular Gravity Sewer

Pipe In @ 6 O'Clock

Infiltration: **None** Pipe Seal Cond: **Sound**
